Manhole Inspection Summary

Manhole # S29YY1001MH

Inspection ☐ Is Incomplete Rating: **4) Poor**

Location Address: **105 COTSWOLD RD**

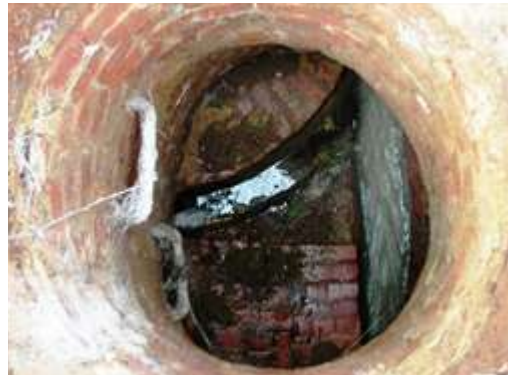
Top View

Evidence of surcharge - Bench debris.

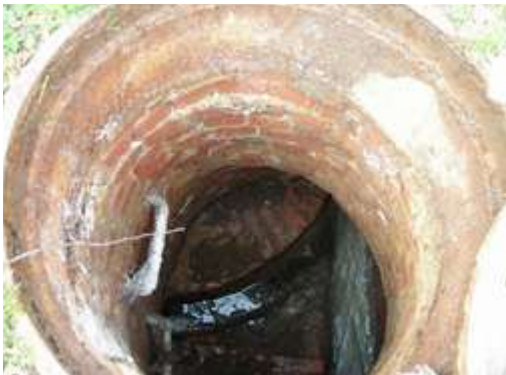
Defect

Frame leaks. Adjustmen deterioration and infiltration. Corbel and Barrel infiltration - other side.

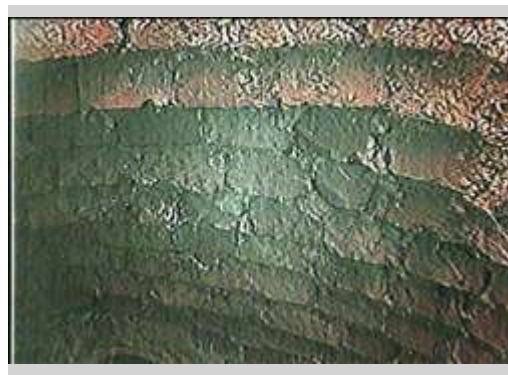
Defect

Corbel and Barrel deterioration and infiltration.

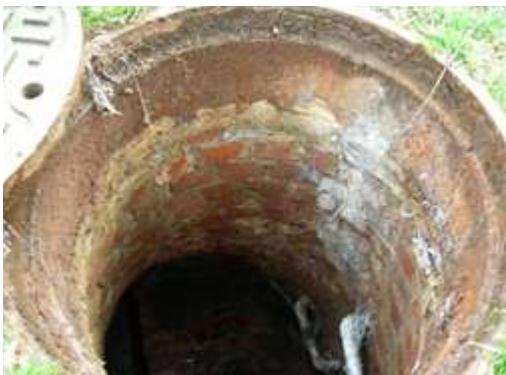
Defect

Frame leaks. Adjustmen deterioration and infiltration. Corbel and Barrel infiltration.

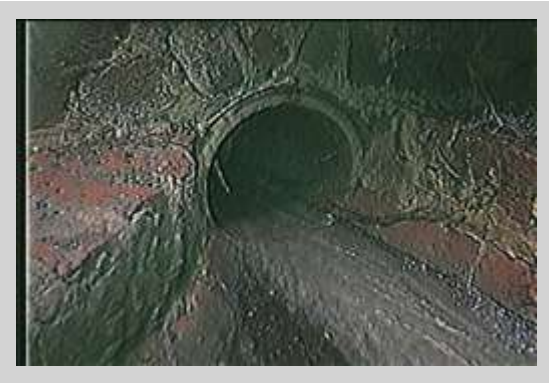
8 in. Circular Gravity Sewer Pipe Out @ 12 O'Clock

Channel deterioration and root intrusion.

Infiltration: **Evidence** Pipe Seal Cond: **Roots**

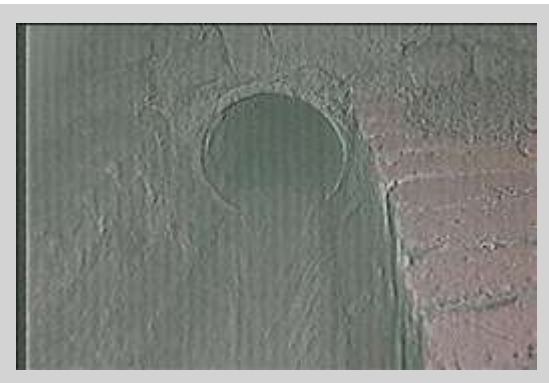
8 in. Circular Gravity Sewer Pipe In @ 6 O'Clock

Infiltration: **Evidence** Pipe Seal Cond: **Cracked**

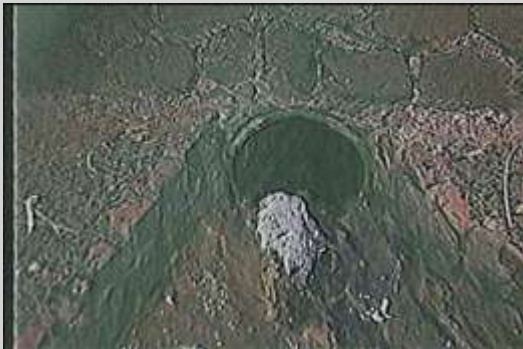
6 in. Circular Gravity Sewer
Pipe In @ 9 O'Clock

Barrel deterioration and infiltration. Channel deterioration.

Deposits: ☐ None ☒ **Mud** ☐ Sludge ☒ **Debris** ☐ Grease
